Report on the investigation of
the structural failure of
MSC Napoli
English Channel
on 18 January 2007

Marine Accident Investigation Branch
Carlton House
Carlton Place
Southampton
United Kingdom
SO15 2DZ

Report No 9/2008
April 2008

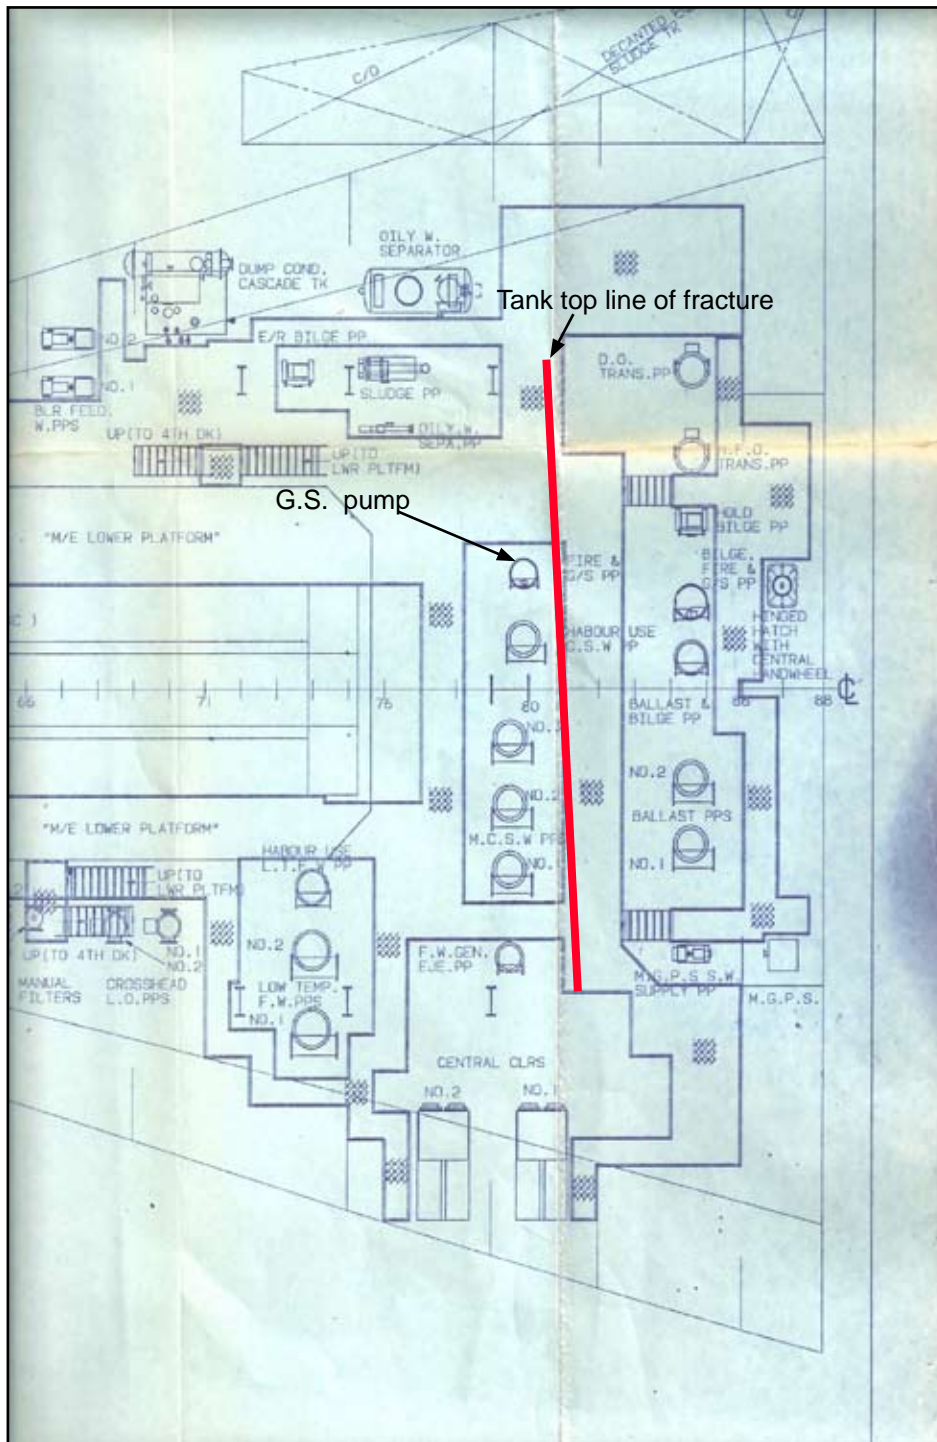
Figure 2

The first assistant engineer quickly joined the third assistant engineer in the ECR. He telephoned the chief engineer on the bridge and informed him of the situation, while the third assistant engineer went to the bottom plates in the engine room to investigate the cause of the alarms. On arrival, the third assistant engineer saw water spraying from the general service (GS) pump delivery pipe just forward of the main engine. The pump was not running and he quickly shut both its delivery and suction valves. This stopped the water flow. The delivery pipe had sheared cleanly across, and the two sections had separated by about 150mm. The third assistant engineer also saw a large quantity of water sloshing from side to side under the engine room bottom plates. As he started to return to the ECR, the tank top forward of the main engine appeared to open up across the ship (**Figure 2**), and a “wall of oily water” shot upwards before cascading down across the pump flat and bottom plates. The third engineer quickly evacuated the area and returned to the ECR.

Forward engine room arrangement showing fracture line

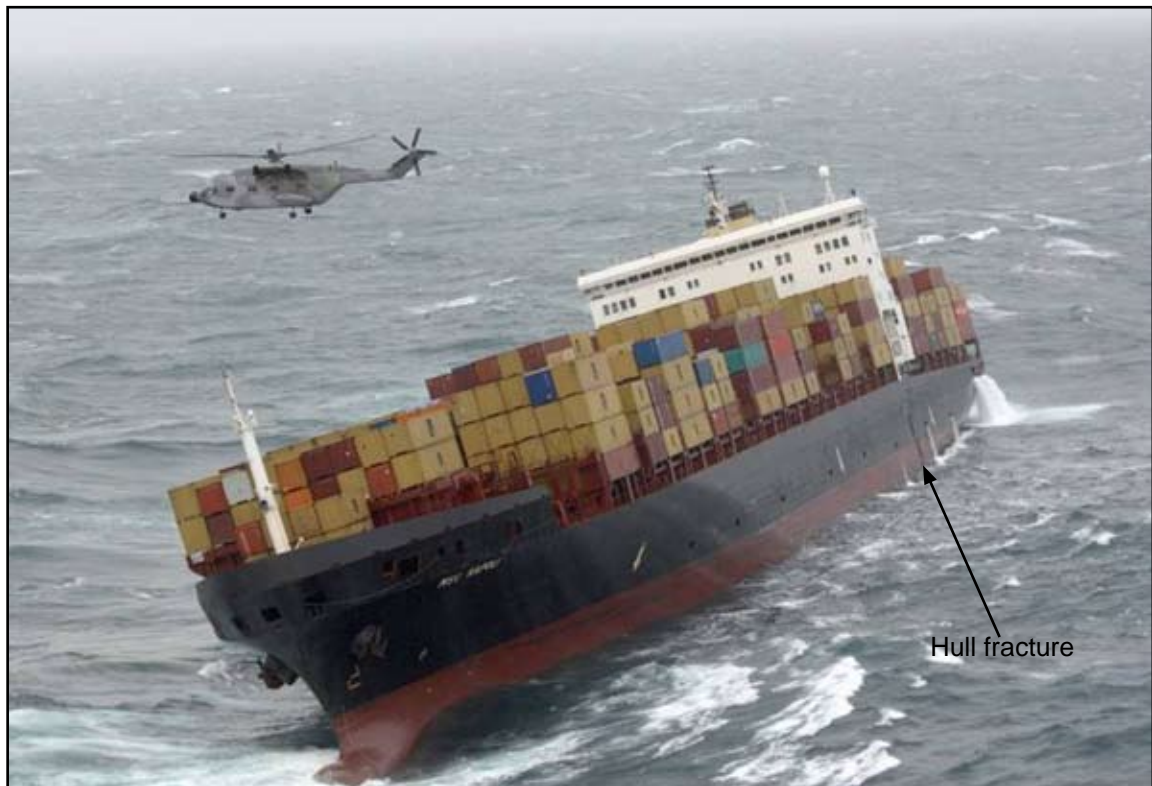
Figure 3

After talking to the chief engineer, the master went onto the starboard bridge wing from where he could see that the ship's side plating directly below the bridge was bulging outwards. He also saw what appeared to be a vertical fracture below the waterline as the ship rolled to port. When similar damage was seen on the port side, the master assessed that *MSC Napoli* had 'broken her back' (**Figure 3**), and decided to abandon the vessel.

MSC Napoli following the structural failure

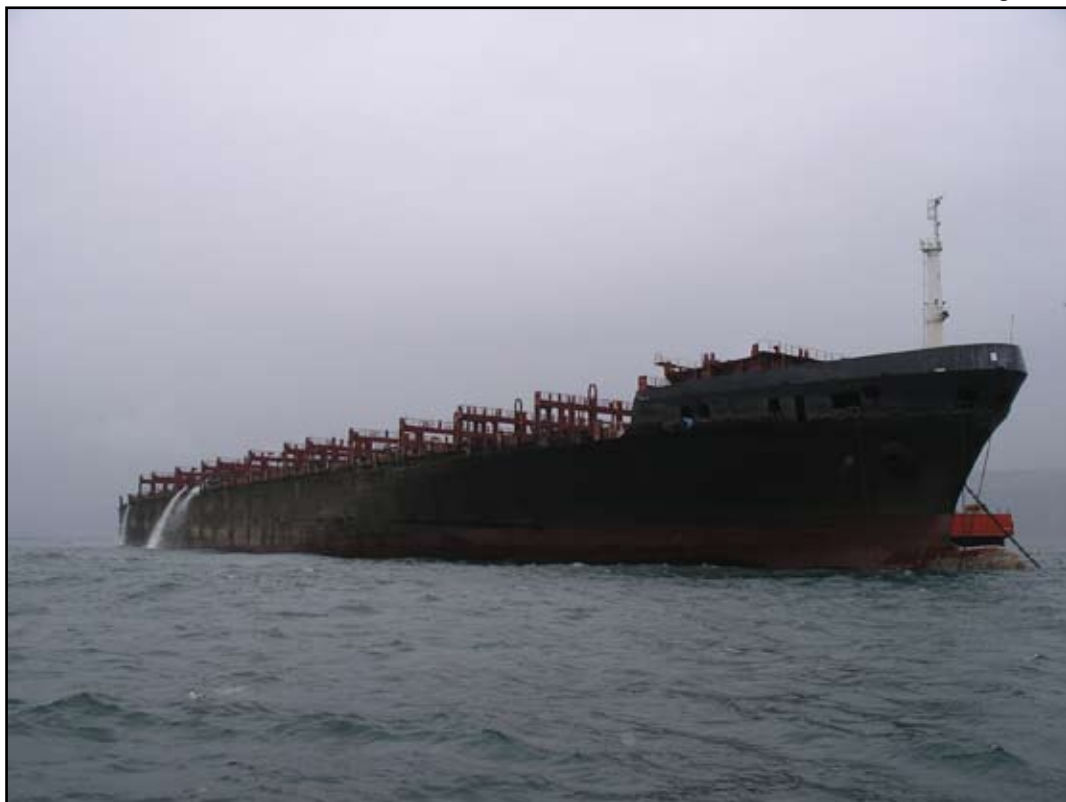
Figure 7

On 20 July 2007, the vessel was separated using explosive charges approximately in way of where the hull had failed on 18 January 2007 (**Figures 7 and 8**). The forward section was then towed to the Harland and Wolff shipyard in Belfast for recycling. The after section remains off Branscombe at the time this report was published.

MSC Napoli - forward section

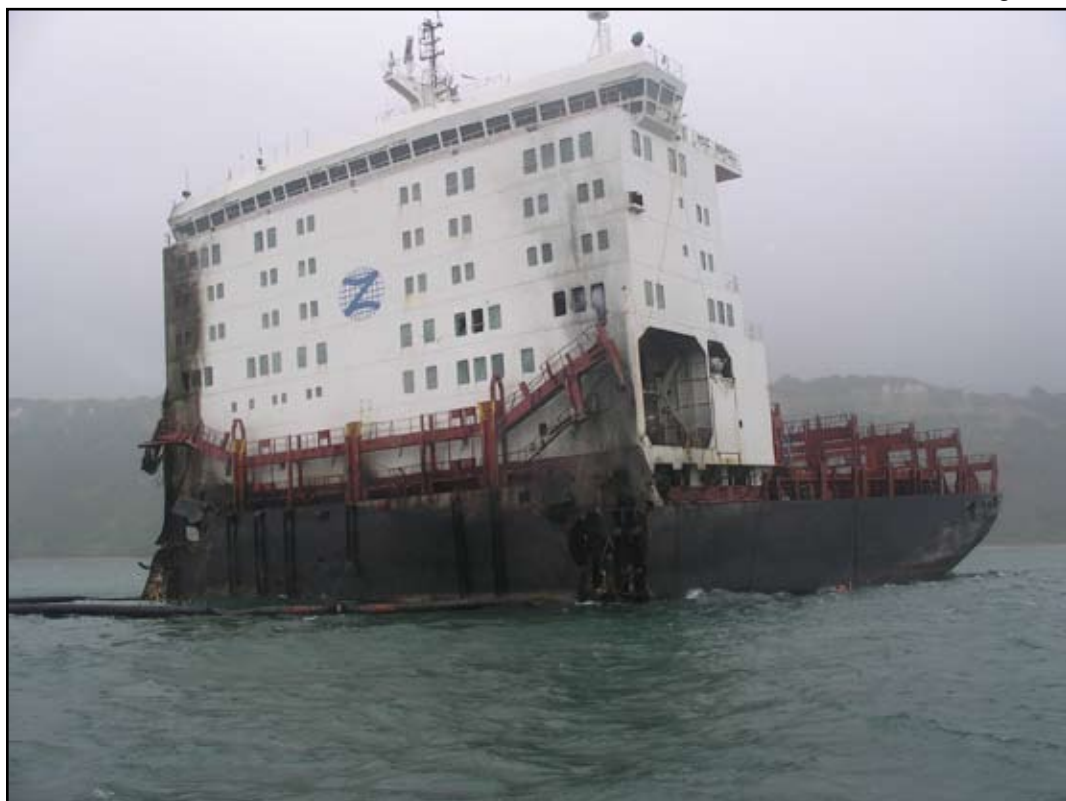
Figure 8

MSC Napoli - aft section

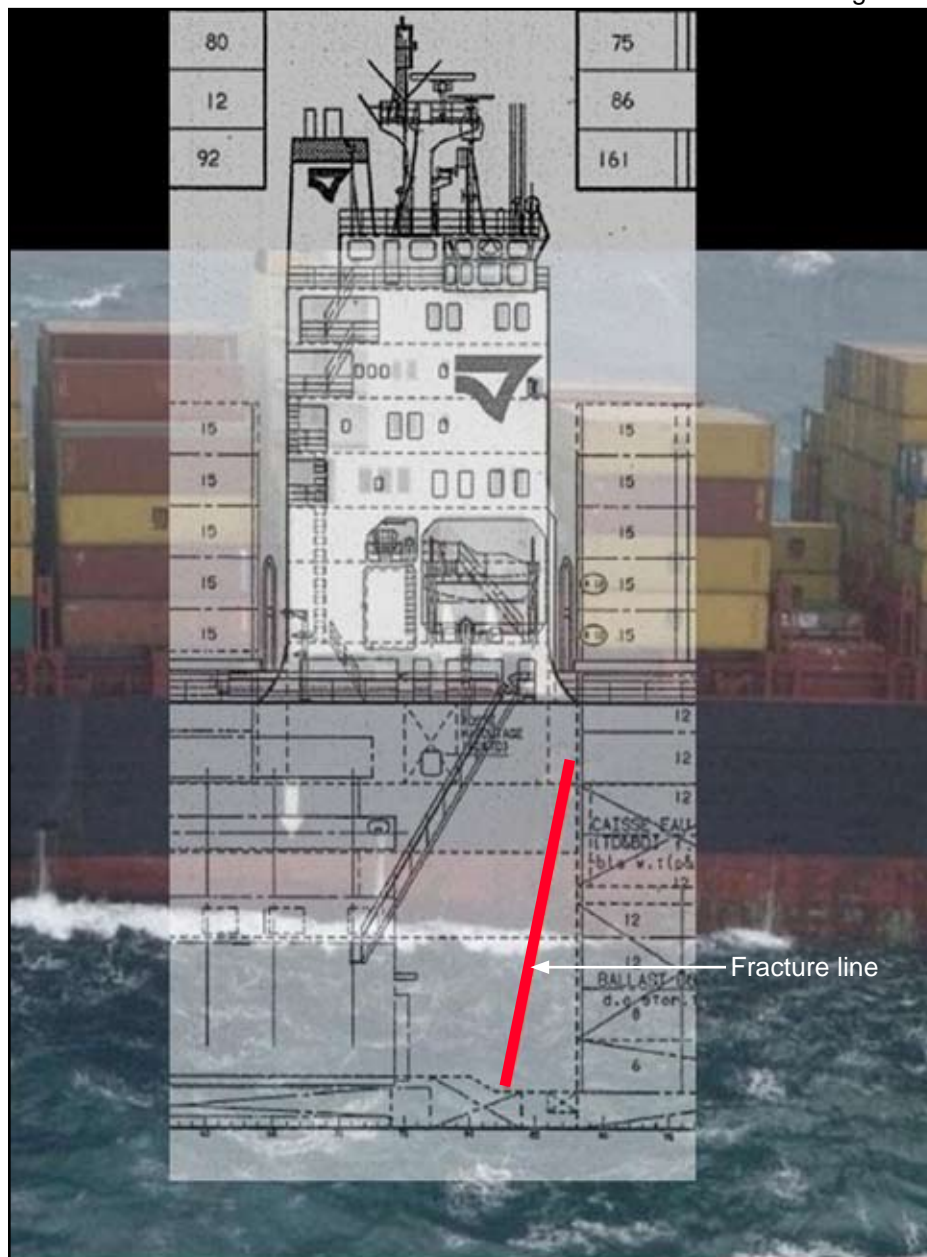
Figure 15

The MAIB completed a number of internal and external surveys of *MSC Napoli* while she was beached at Branscombe Bay. Dive and on board surveys indicated that the hull fracture on the starboard side of the ship extended from the bottom hull plating at frame 82, upwards and forwards to frame 88 via the sea chest area (**Figure 15**).

Path of fracture line established during dive surveys

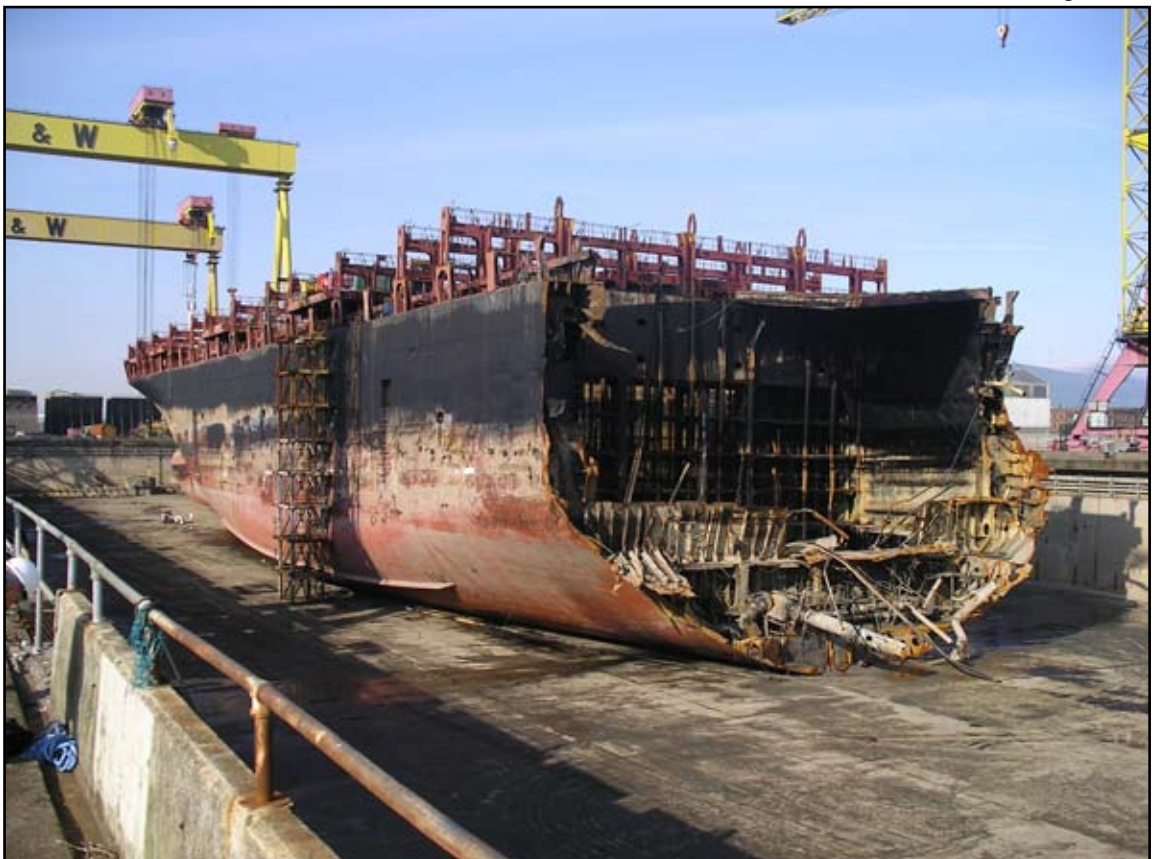
Figure 16

There was no indication of any damage to the bow area, or the forward-most containers. Once the forward section of the hull had been detached and taken to the Harland and Wolff dry dock (**Figures 16-18**), it was possible to perform a more detailed inspection of the fracture, which confirmed the earlier indications with respect to the path of the failure.

The inspections in Belfast were able to confirm that the vessel had been built in accordance with the ship's drawings. It was established that not all longitudinal girders in the double bottom were continuous in the area of the failure. While the port side girders were continuous, the centreline and starboard side girders were intercostal between floors. In addition, it was noted that there were fractures through the throats of fillet welds at the sites of discontinuous longitudinal girders, while the continuous girders had generally failed mid frame.

Forward section of hull in Belfast dock

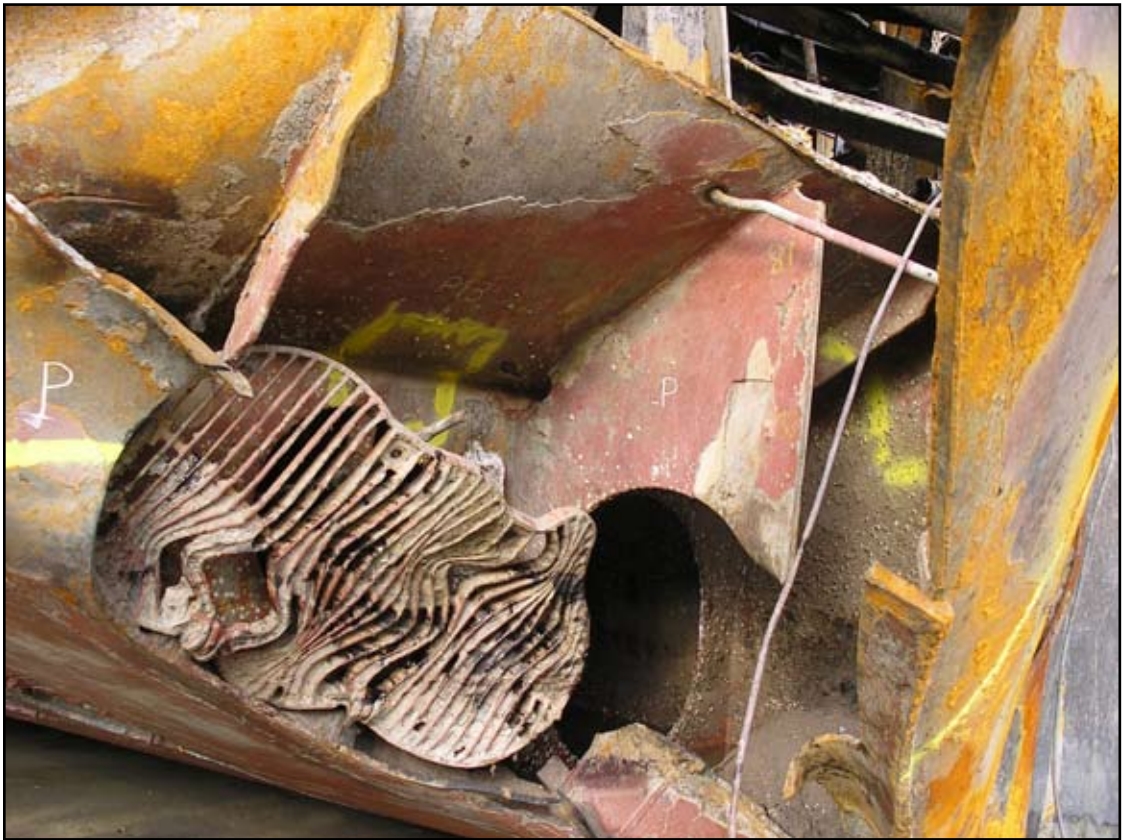
Figure 17

Localised plate buckling - port sea chest

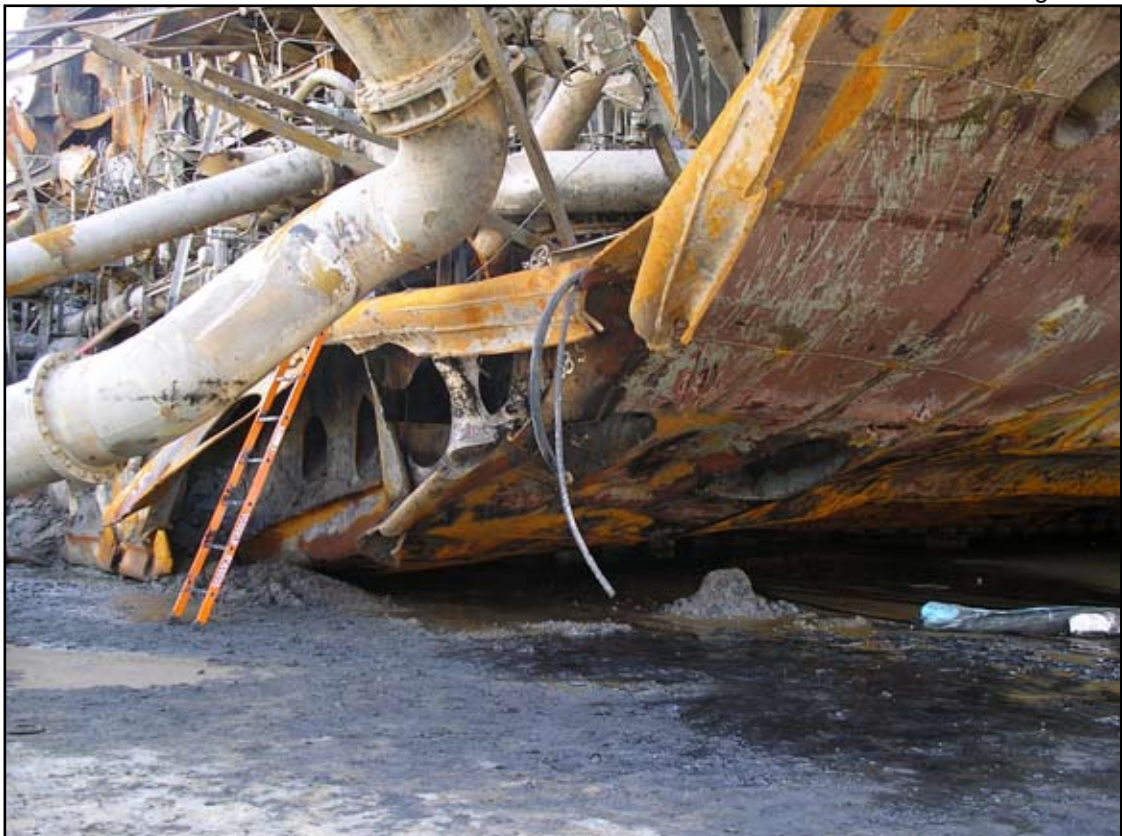
Figure 18

Starboard side hull collapse near lower sea chests

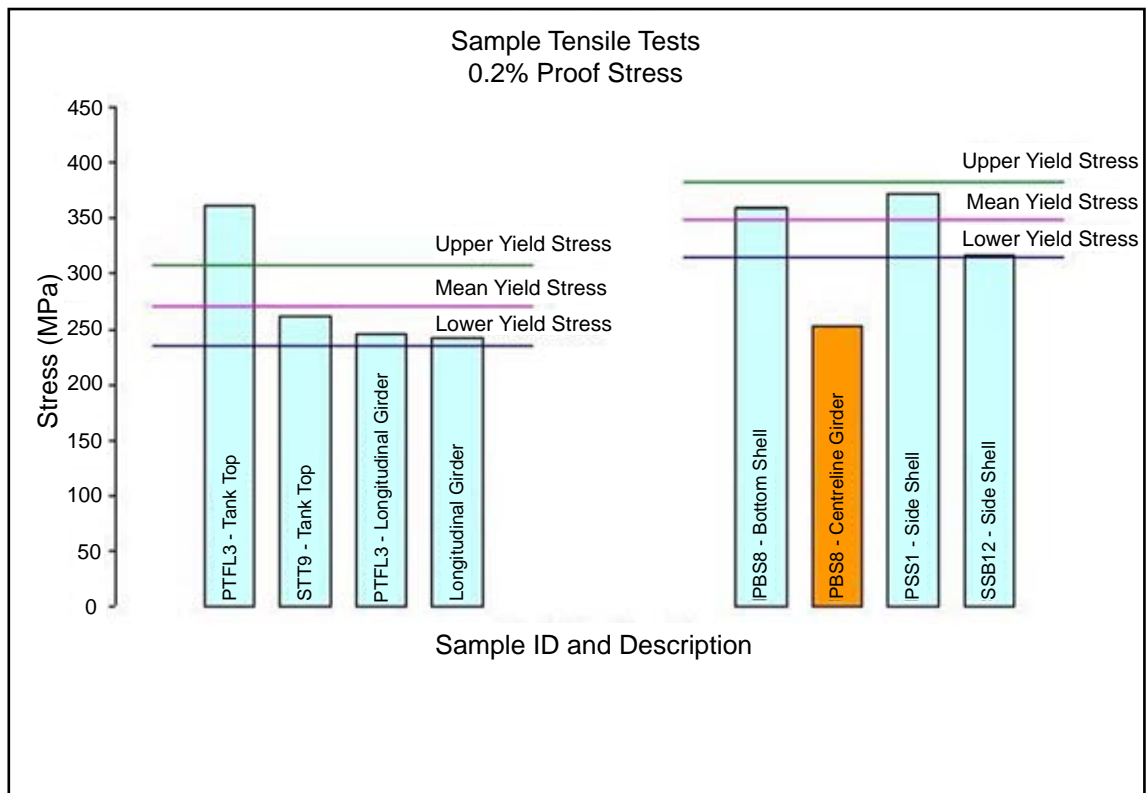
Figure 19

The grades of steel used in the construction were generally as specified in the vessel's drawings, or of higher grade (**Figure 19**). The only sample that did not meet the required properties was the centreline girder, where mild steel (Grade A) was used instead of high tensile steel (AH32).

Comparison of tensile steel results with expected yield stress ranges

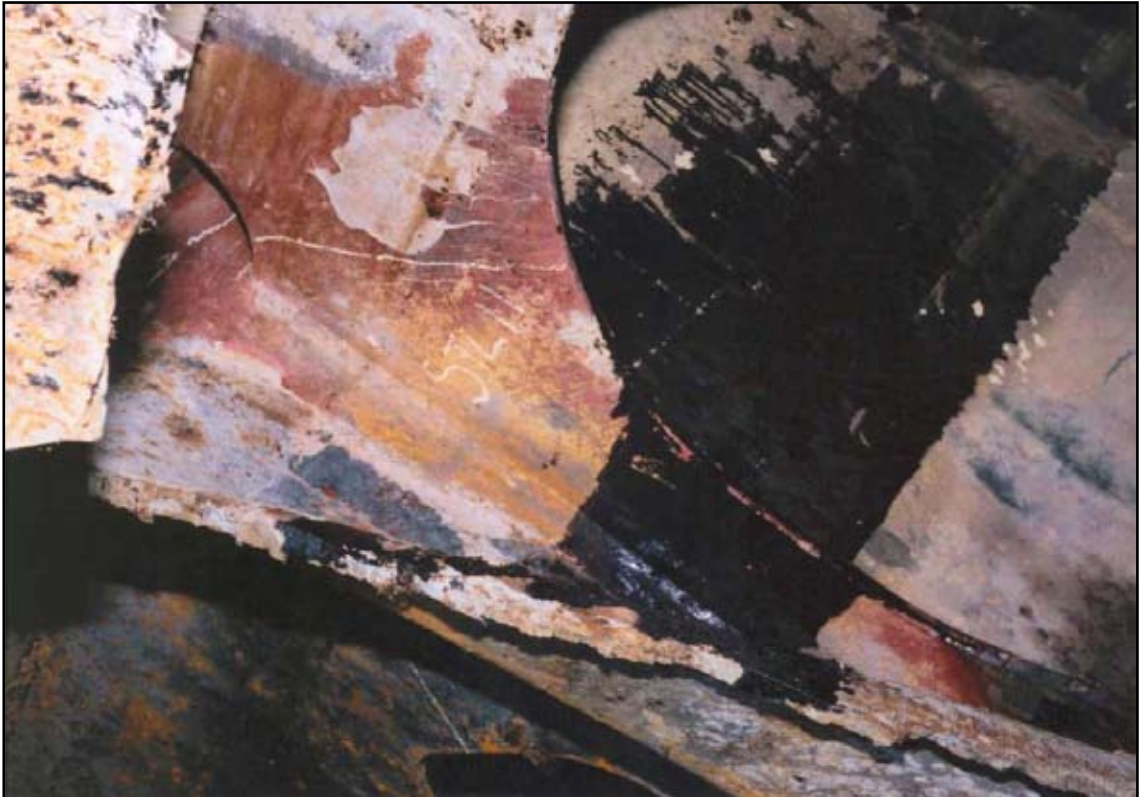
Figure 20

Three of the steel samples showed evidence consistent with repairs or joint repositioning being completed when the ship was in service. One of these samples (STL11), which was taken from the connection between a transverse floor and longitudinal girder number 3 at 6050mm off the ship's centre line inside the starboard sea chest at frame 84 (**Figure 20**), exhibited evidence that at least one of the four fillet welds forming the cruciform joint (**Figures 21 and 22**) had been repaired. With regard to this sample, the Test House report (**Annex C**) concluded "*Piece STL11 exhibited a fatigue crack that had initiated from a region of weld metal exhibiting pre-existing centre bead segregation, or liquation type hot cracking. The lower fatigue portion of the crack, by contrast, contained an in situ corrosion product consistent with its formation in a marine environment. Collectively, the evidence suggests that a solidification defect had been present in the throat of the original construction weld. The crack had grown by a mechanism of fatigue and had been open to the elements, during which time the lower crack regions had suffered corrosion. The crack had then been partly excavated and a capping weld run applied over the previously open and corroded crack.*"

Transverse floor and longitudinal girder number 3 at 6050mm off centre line (including fillet weld connection) inside sea chest, frame number 84 starboard side prior to removal from the vessel

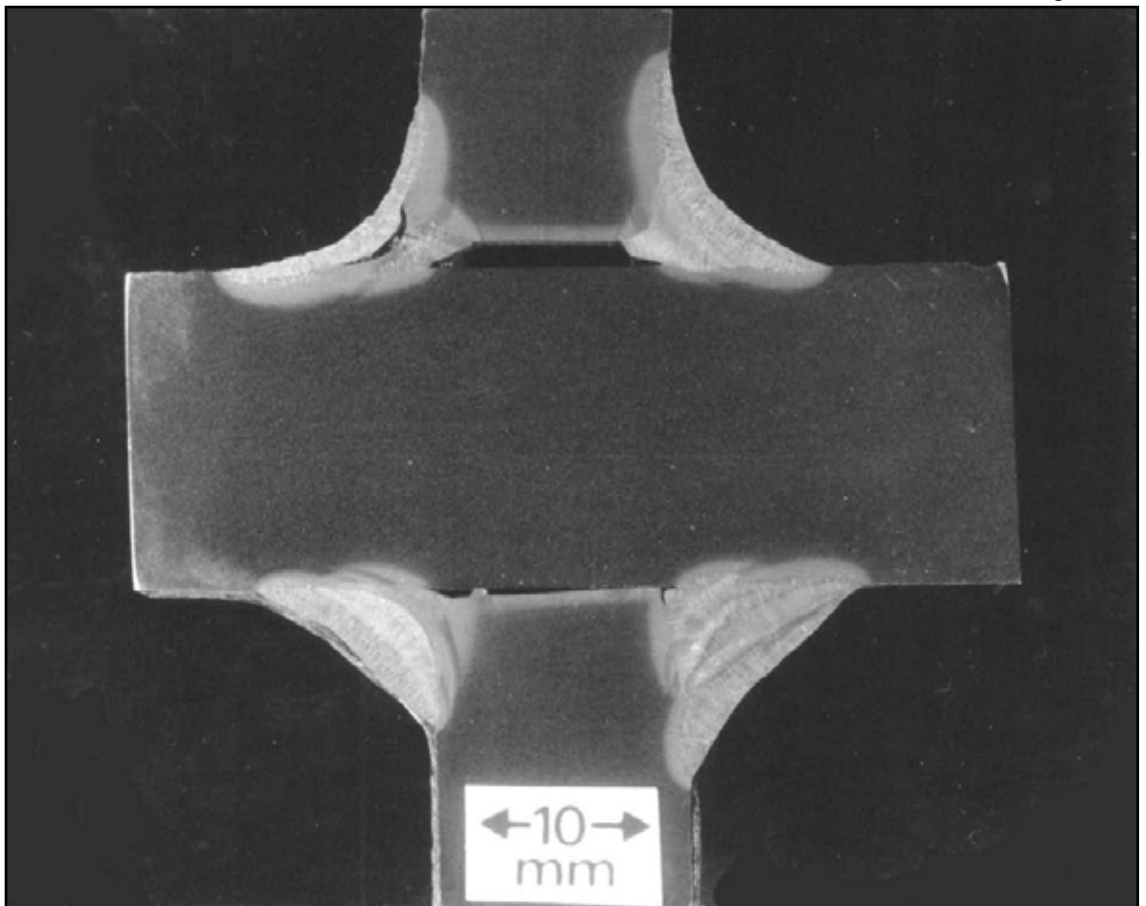
Figure 21

Macrophoto of specimen taken from sample removed from the sea chest showing weld repair

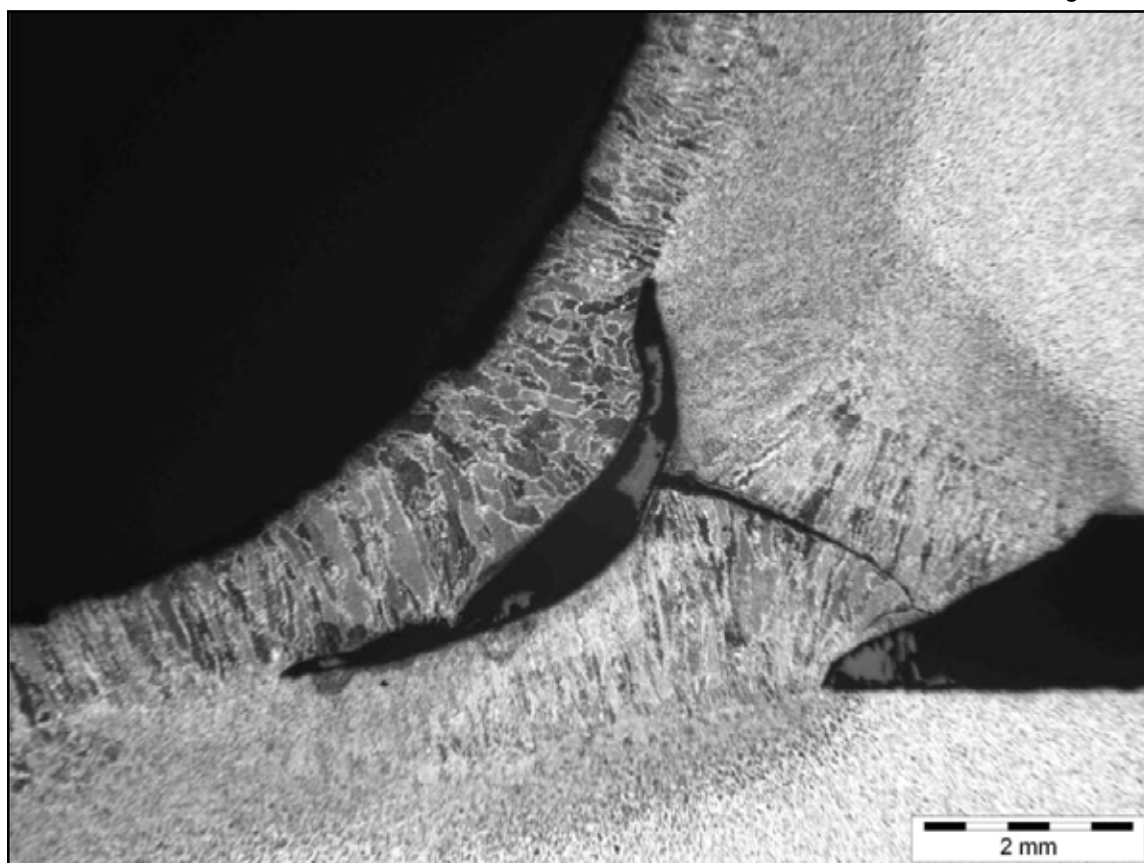
Macrograph of specimen taken from sample removed from the starboard sea chest showing detail of fatigue crack and repair

It was not possible from the metallurgical evidence available to determine when the repairs were conducted, and no record could be found of any welding repairs to the ship's main structural girders in way of her engine room.

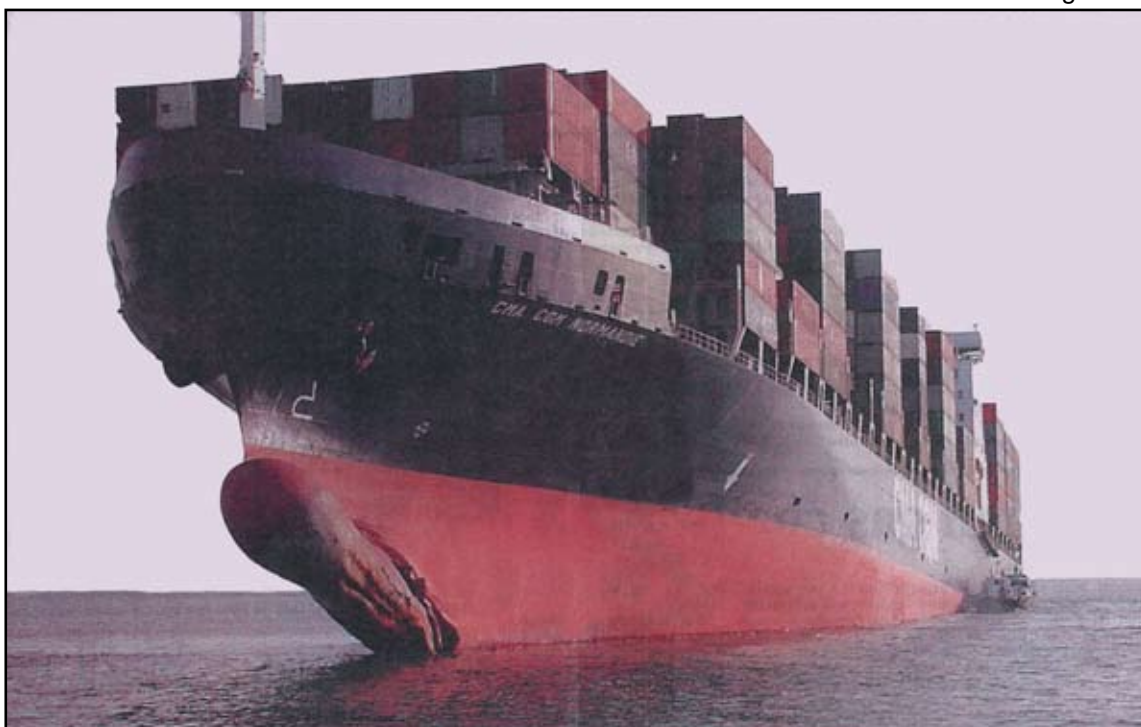
During a routine dry docking in January 2001, the vessel's starboard side hull plating was indented following misalignment of the blocks. Permanent repairs were completed in March 2001. In April 2001 the vessel ran aground at full sea speed in the Malacca Straits (**Figure 23**). Material damage was caused to the bottom plating and internal structures from the bow to frame 210 (**Figure 24**). Cargo holds No. 1 to No. 4, the bulbous bow, the fore peak tank, No. 1 deep tank and the bow thrusters room were all flooded. The vessel was aground for 60 days while cargo was removed. She was then towed to Vietnam, where approximately 90m of the forward section of the vessel (bow to frame 212) from the keel to the summer load line (15m) was replaced. This required 3000 tonnes of steel.

MSC Napoli (formerly *CMA CGM Normandie*) aground in 2001

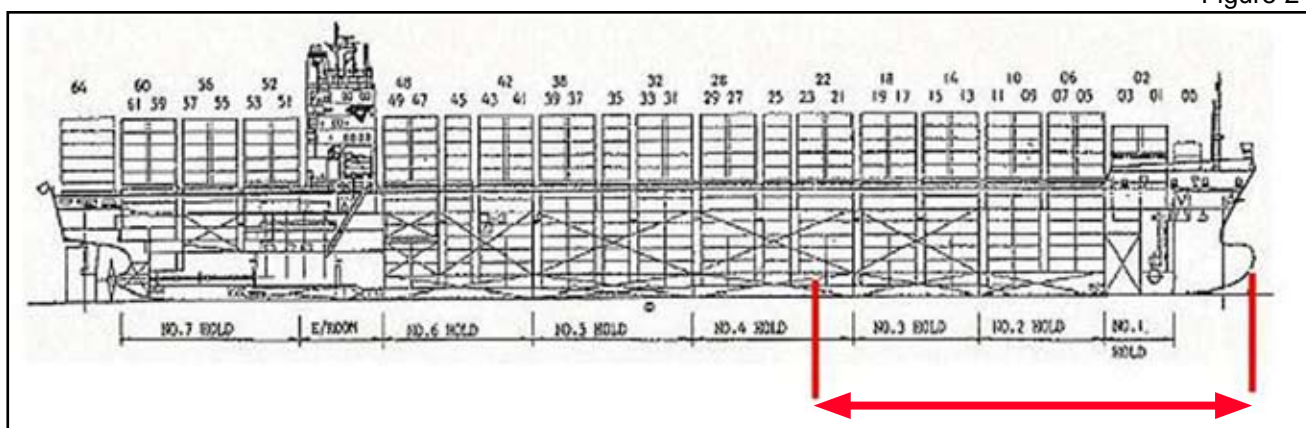
Extent of bottom damage

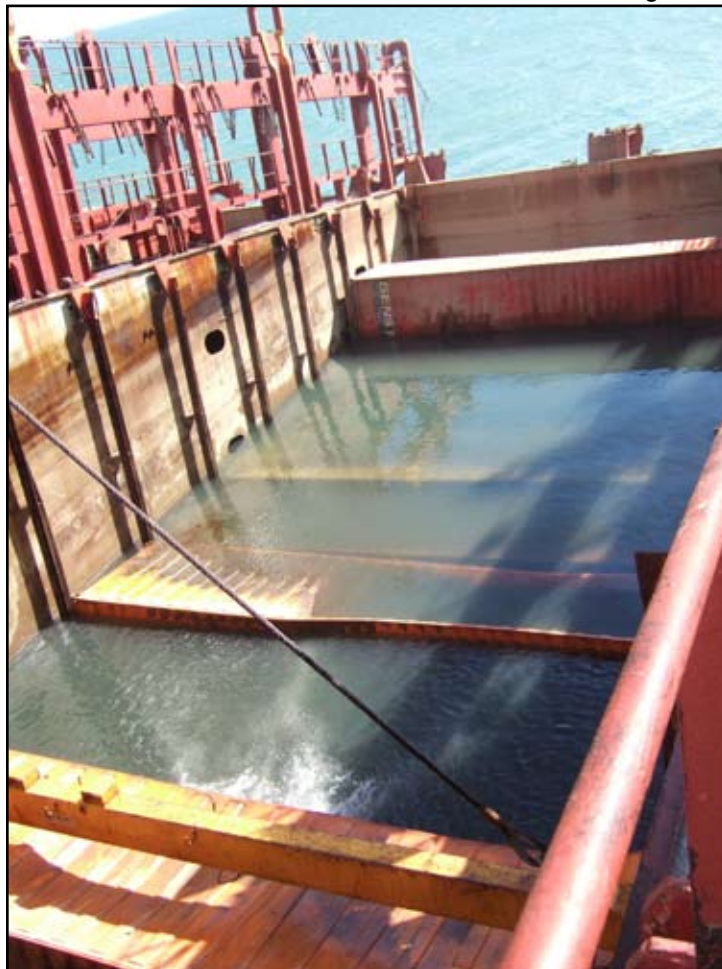
Figure 25

During the removal of the containers, the positions of 700 containers on deck were compared with the positions recorded by the terminal operator (i.e. the positions entered into the loading computer to determine the stability condition). Of these units, 53 (7%) were in either the wrong position or declared as the wrong container. It is generally agreed within the container industry that up to 10% of containers loaded onto a vessel might not be in their planned positions.

Waterlogged containers in hold

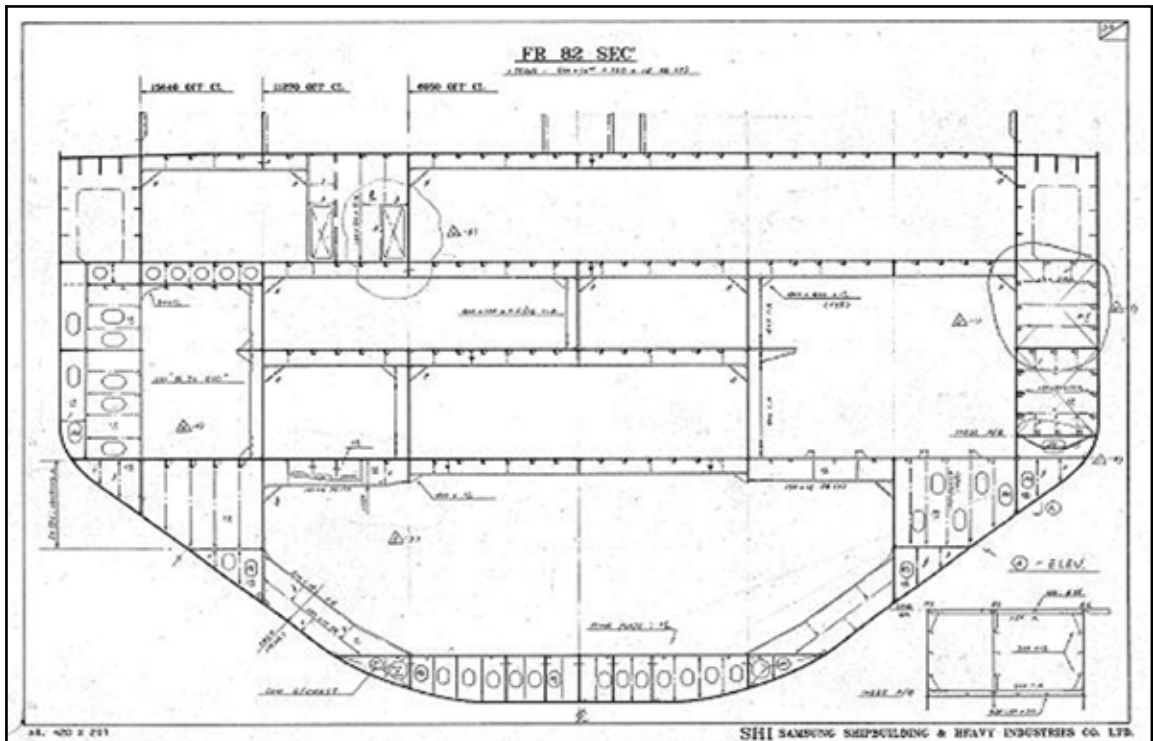
Frame 82

Similar results were obtained for the two sets of rules. A number of panels in the tank top, bottom and lower side structure in the region of frame 82 were found to be deficient (**Figure 29**). Other panels, although passing the buckling checks, were close to the buckling criteria. Consequently, it is likely that when the vessel's hull girder strength was reduced due to the buckling of the weaker panels, the remaining structure had insufficient margin to withstand the increased load. This failure mechanism is consistent with the failure mechanism identified in the FE analyses.
