JRC - Learning Opportunity Notification (LON) - 001

Incident Details		Incident Impact	
Incident	Piper Alpha	People	167 dead
Date of Incident	06-Jul-88	Environment	Pollution
Location/Country	North Sea, UK	Asset (adjusted claim at the time of loss)	USD \$1,480 million
Type of Incident	Explosion	Reputation	Operator withdrew from UK
Offshore/Onshore	Offshore

Asset Type	Fixed Platform		
Asset Status	Operational		
Immediate Cause	Loss of Containment		
Similar Root Cause Incidents	LON - 002, LON - 003		
Date Updated	01-Oct-20

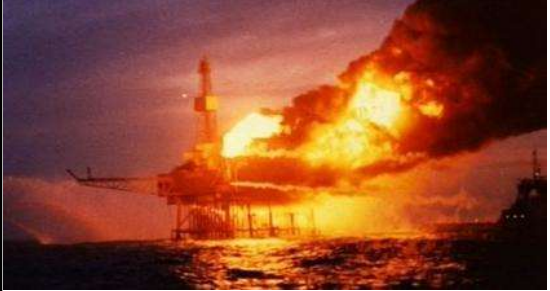
Just before 22:00hrs, whilst pump A's PTW was still active, pump B tripped and could not be restarted. The operator checked the live PTWs and could not locate the PTW of Pump A (as it was placed at a different location) and started pump A, believing the maintenance work had not yet started. Due to pressure built up in the line and a possible loose connection of the temporary blind flanges, a release and ignition of gas condensate from the blind flange set off a chain of fires, explosions and three high pressure gas line ruptures, resulting in the almost total destruction of the facility.

The severity of the accident was largely due to the contribution of oil and gas from ruptured pipelines and the disabling of nearly all emergency systems, as a result of the initial explosion. Firewalls between the modules failed and damaged the pipings connected to the adjacent module. The compression module had been retrofitted to the platform adjacent to the control room, which was rendered useless by the initial explosion. In addition, the firewater pumps had been placed in to manual operation mode due to divers being in the water prior to the accident. Living quarters were located directly above the initial release, which was a major contributory factor to the loss of life. Smoke and flames outside of the accommodation module made evacuation by helicopter or lifeboat impossible.
