JRC - Learning Opportunity Notification (LON) - 002

Incident Details		Incident Impact	
Incident	Mumbai High North	People	22 dead
Date of Incident	27-Jul-05	Environment	Pollution
Location/Country	Arabian Sea, India	Asset (adjusted claim at the time of loss)	USD \$370 million
Type of Incident	Boat Impact	Reputation	
Offshore/Onshore	Offshore

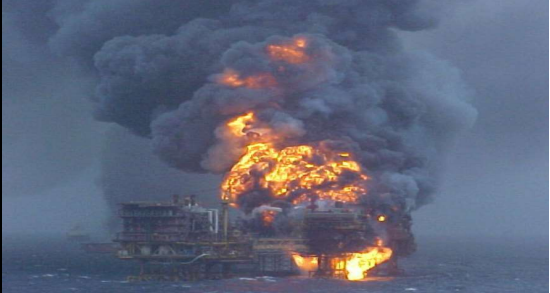
At around 16:05 hours, strong swells pushed the MSV towards the MHN platform, causing the helideck at the rear of vessel to strike and sever one or more gas export risers on the MHN jacket. The resultant gas leak ignited within a short time. The close proximity of other risers and lack of fire protection caused further riser failure. The subsequent fire engulfed the platform MHN, causing the complete destruction of the MHN platform along with the bridges connecting other platforms. Emergency shut-down valves (ESDVs) were in place at each end of the risers and the flow was shut down via sub-surface ESDVs, but some risers were up to 12 km long and riser failure caused large quantity of gas to be uncontrollably released. The fire also engulfed the MSV Samudra Suraksha, with heat radiation causing severe damage to the NA platform and the Noble Charlie Yester jack-up. The MSV caught fire and its personnel had to abandon the vessel. Six divers in saturation chambers on MSV were left behind when the vessel was abandoned but rescued 36 hours later. The MSV suffered extensive fire damage and was towed away from scene but later sank on 01 Aug 2005, about 18km off the coast. A helicopter on-board the platform was also lost. Personnel on-board Noble Charlie Yester, which also was affected by the fire, jumped into the sea. A clean-up operation was also performed after a 10 nautical mile oil spill resulted from the fire.

Process Safety Management (PSM) - Although ESDVs were initiated, the MHN platform topsides collapsed within two hours of the initial fire, leaving only the heat distorted top of the jacket above sea level. The scale of the fire was due to the large inventory in the risers – a risk based study should have been undertaken to consider justification of a Subsea Safety Isolation Valve (SSIV) on larger inventories. A thorough HAZID and HAZOP analysis should have been performed during the design and operational stage to identify those risks and manage the risks.

Layout/Design - The location and vulnerability of the risers in the jacket relative to platform loading zones was compromised. Some riser protection guards were in place just above sea level, but these were only suitable for smaller offshore supply vessels and were not considered suitable for larger multi-purpose support vessels. Riser guards (protection barriers etc.) weren't provided at the top of the riser section.

Fire/Blast Protection – Risers had no active or passive fire protection on MHN. Active and passive fire protection on the risers may have reduced the severity of the loss.
