JRC - Learning Opportunity Notification (LON) - 004

Incident Description

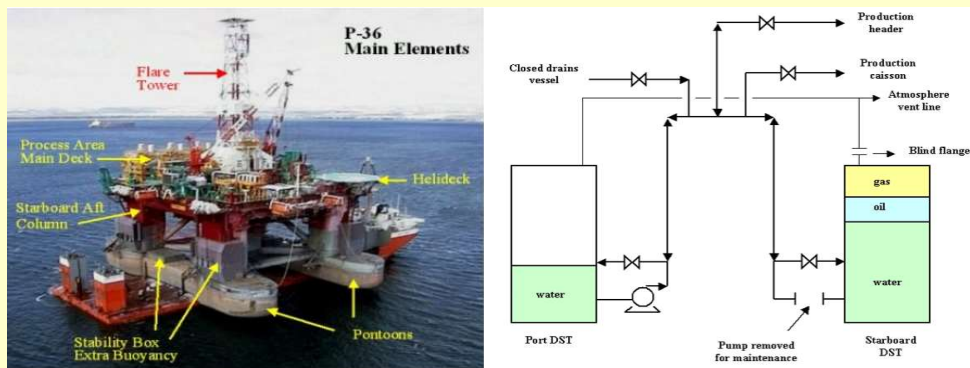
Figure 1: P-36 Unit and The Process Flow Diagram of Drainage Tank (Ref 2)

Before the incident, on 10 February 2001, a Drain Storage Tank (DST) located in starboard aft column had been shut-down and supposedly isolated. However, leakage of volatile fluids and gases through a valve, over-pressurized the tank, bursting at 00h22 on 15 March 2001. Figure 1 presents the P-36 unit and the process flow diagram of the drainage tanks.

As a result, pressure had built up to around 10 bar in the starboard tank and it ruptured at around 00h:22 on 15 March 2001. This caused the 18" seawater service pipe adjacent to the DST to rupture and the process plant automatically entered into emergency shutdown mode, with the 4th level of the starboard aft column starting to flood. Over the next 17 minutes, 1,723 alarms were triggered. Operations dispatched the Emergency Response Team (ERT) and activated the seawater service pipe, which instead of supplying water to the ERT was now also contributing to the flooding of the starboard aft column. Around 20 minutes after the first explosion (00h39), there was a second, high-intensity explosion caused by the ignition of the natural gas released from the column (although the ignition source was not identified), reaching the tank top and the second deck and killed ERT members. Rapid flooding of the lower levels of column was in part caused by flow through the ventilation system from the 4th level, when dampers failed to close.

The leakage of volatile fluids into an isolated DST resulted in bursting of the tank and rupturing the seawater caisson. The proximity of the DST to the seawater service pipe inside a key support column created a common mode of failure, but there was no record of hazard analysis conducted for this design.

Design Layout - Poor design placement of key safety-critical parts - pressurization and mechanical bursting of the tank, rupturing the seawater service pipe and releasing flammable materials into the support column should have been avoided. During the design stage, abstain from placing any tanks or vessels linked to the production process inside the support columns or pontoons, or other components where damage could compromise stability. Seawater service pipe redundancy should also be considered during the design stage. Further, redundancy or protection of inlet valves of DST should be considered for future designs.
