JNRC - Learning Opportunity Notification (LON) - 005

Incident Details		Incident Impact	
Incident	Longford Gas Plant	People	2 dead / 8 injured
Date of Incident	25-Sep-98	Environment	Minimal
Location/Country	Longford, Victoria, Australia	Asset (adjusted claim at the time of loss)	USD 633 million (PD, BI & Liability)
Type of Incident	Fire	Reputation	Significant reputational damage to Operator
Offshore/Onshore	Onshore

Asset Type	Onshore Processing		
Asset Status	Operational		
Immediate Cause	Loss of Containment		
Similar Root Cause Incidents	LON - 001, LON - 002		
Date Updated	19-Aug-22

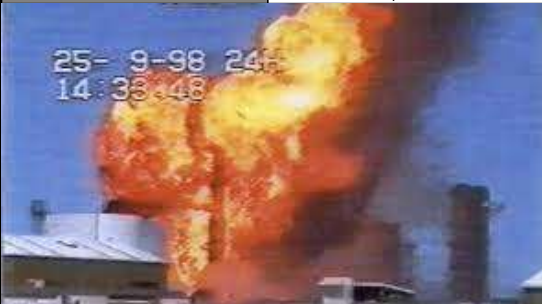
At the time of the loss, the gas plant was restarting after an extended period of process upset due to high liquid flow into the slug-catchers. GPS 1 was in a highly transient state, and experienced rapid changes in temperature. A heat exchanger, GP905, known as the De-methaniser Reboiler, failed catastrophically when warm oil was reintroduced after a period of cooling.

The failure released more than 10 tonnes of hydrocarbon vapour, with the cloud drifting for an extended distance (~170m), before igniting off a set of fired heaters. The resulting fierce jet fire caused three further fires due to impingement on an elevated piperack junction and burned for over 2 days due to the absence of remote operated isolation valves (ROIVs) between interconnected units.

The basic cause of the loss of containment that resulted in the widespread fires was a brittle fracture of the De-methaniser Reboiler as result of experiencing a low temperature of minus 42 deg.C, followed by relatively rapid return to a normal temperature of 100 deg.C.

- cold metal embrittlement of carbon and low alloy steels is a threat (low probability - high consequences) that is often overlooked. Ideally this should be dealt with by selection of a suitable material of construction - but when this is not considered appropriate, yet the threat remains, wide plant design, procedure and training should all reflect the present threat;

- ROIVs should be installed in line with a suitable standard to allow for rapid isolation of large process inventories, and mitigation of event escalation;
