## JNRC - Learning Opportunity Notification (LON) - 006

Incident Details		Incident Impact	
Incident	Deepwater Horizon (Macondo)	People	11 dead
Date of Incident	20-Apr-10	Environment	Pollution
Location/Country	Gulf of Mexico, USA	Asset (adjusted claim at the time of loss)	USD \$685 million (Insured Loss)
Type of Incident	Control of Well	Reputation	Major reputational damage to Operator
Offshore/Onshore	Offshore

Asset Type	Semi-Submersible		
Asset Status	Well-Drilling		
Immediate Cause	Inadequate Barriers		
Similar Root Cause Incidents	Montara/West Atlas		
Date Updated	19-Aug-22

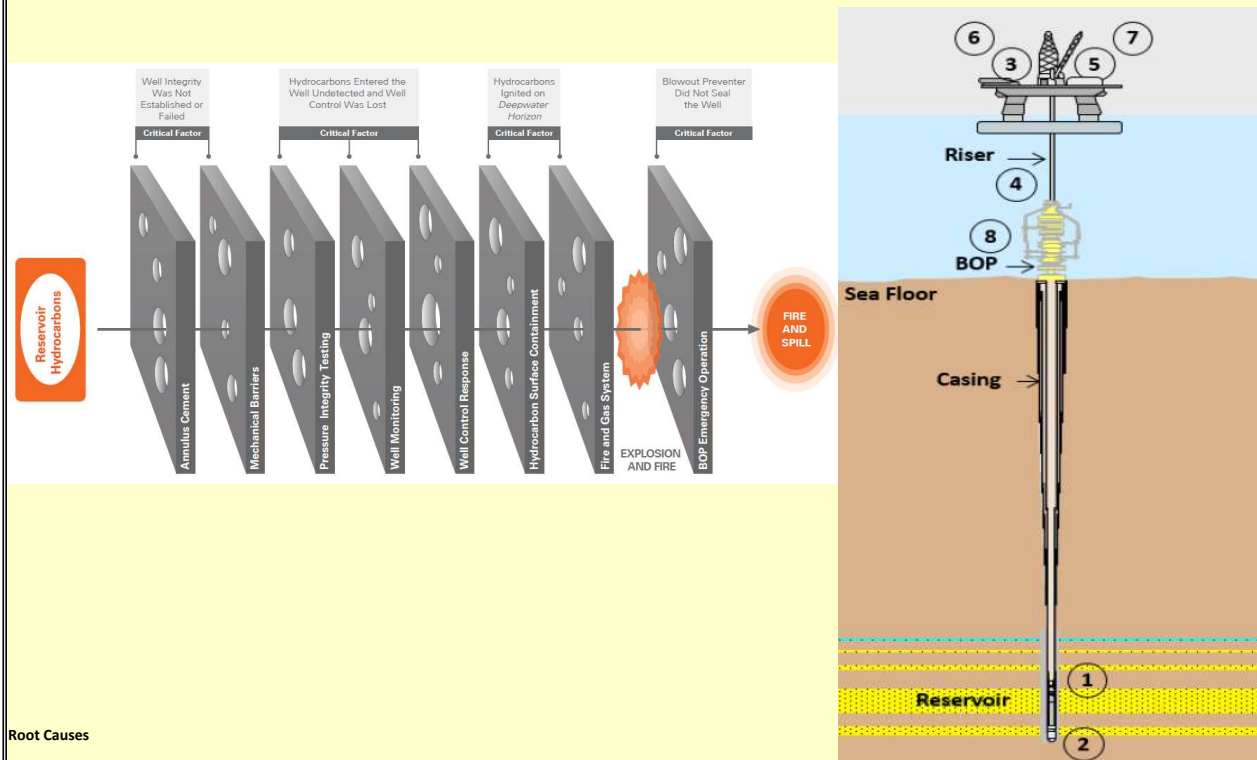
A complex and interlinked series of mechanical failures, human judgements, engineering design, operational implementation and team interactions came together to allow the initiation and escalation of the Deepwater Horizon (Macondo) incident. The Operator incident investigation (Ref. 1) surmised that the following critical factors had to have been in place for the incident to have progressed as was seen (refer to below schematics also):

1. The well annulus cement barrier did not isolate the hydrocarbons. The annulus cement that was placed across the main hydrocarbon zone was a light, nitrified foam cement slurry. This annulus cement probably experienced nitrogen breakout and migration, allowing hydrocarbons to enter the wellbore annulus, and as such cement formulation was inadequate for intended service.
2. The well shoe track barriers did not isolate the hydrocarbons. Once hydrocarbons entered the well annulus, they migrated into the production casing via the shoe track. Two barriers in the shoe track failed being the shoe track cement and the float collar.

3. The negative pressure test which was used to verify integrity of well mechanical barriers including the failed shoe track was misinterpreted providing a false conclusion of sound well integrity and providing justification for removal of the heavy drilling fluid to leave the well "underbalanced" i.e., formation pore pressure exceeding wellbore pressure enabling influx to the wellbore.
4. Influx was not recognised until hydrocarbons were in the riser. Increases in drill pipe pressure were discernible at least 40 minutes prior to the rig crew taking action to control the well.
5. Well control response actions failed to regain control of the well. Well fluids were diverted to the rig mud gas separator instead of the overboard diverter line which reduced the time to respond and escalated the incident.

6. Diversion to the mud gas separator resulted in gas venting onto the rig. This increased the potential for gas to reach an ignition source.
7. The fire and gas system did not prevent hydrocarbon ignition.

8. The BOP emergency mode did not seal the well due to a combination of factors including faulty components, improper maintenance and impairment of the function from the explosion.
