Report on the investigation of
the structural failure of
MSC Napoli
English Channel
on 18 January 2007

Marine Accident Investigation Branch
Carlton House
Carlton Place
Southampton
United Kingdom
SO15 2DZ

Report No 9/2008
April 2008

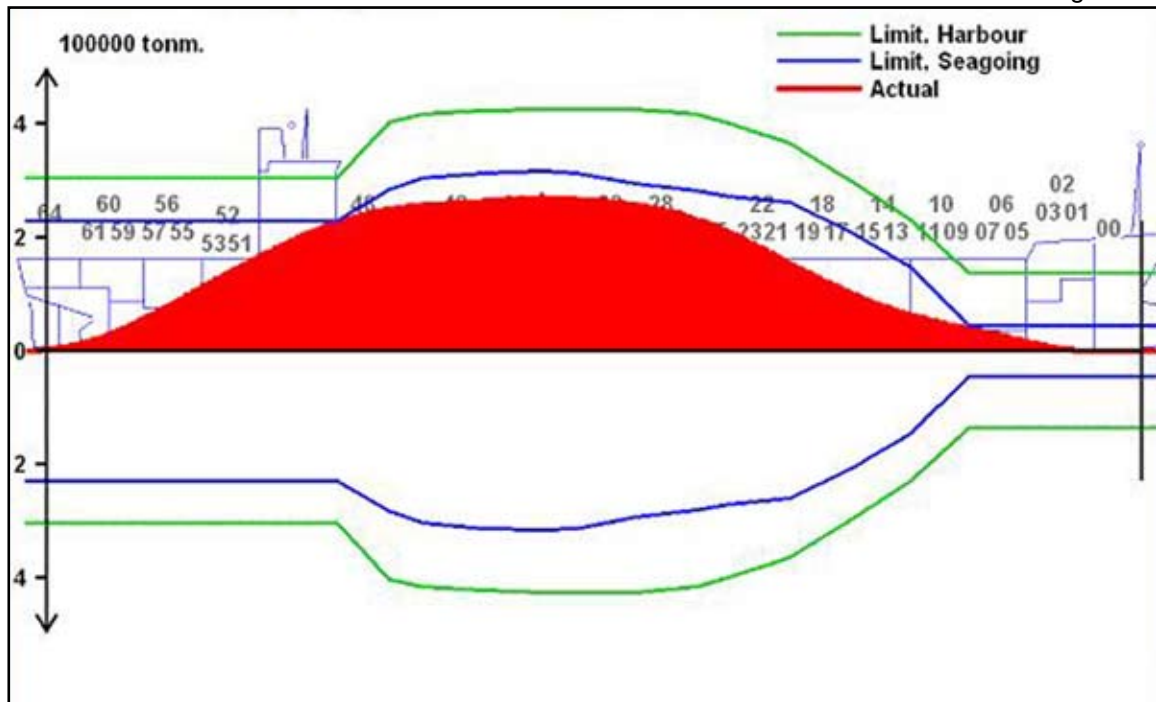
Figure 12

completed by 1510 and had the effect of reducing the seagoing bending moments to 99% of the allowed maximum (**Figure 12**) and of increasing the draught aft to about 13.5 metres. The pilot was not informed of the changes in draught and trim.

Condition on leaving the River Schelde

The still water loading condition applicable at the time of the hull failure produced a hogging bending moment at the engine room bulkhead (frame 88) of 2243MNm. This was 98.9% of the vessel's seagoing limit (**Figure 12**). Shear forces and torsional moments were also within acceptable limits.

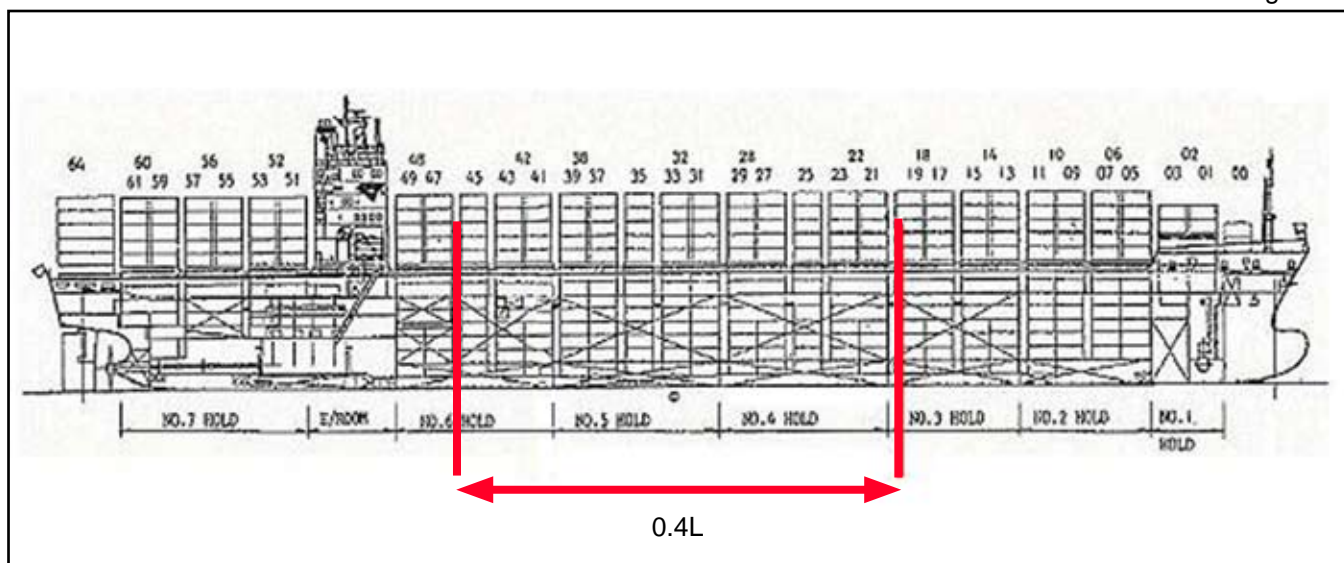
Figure 13

MSC Napoli profile showing 0.4L amidships region and engine room

BV's rules also specified the buckling criteria which was to be used to assess hull scantlings, but these criteria were only applicable to 0.2L¹⁴ either side of a vessel's midships (frames 102 to 232 on *MSC Napoli*) (**Figure 13**). No buckling calculations were required to be undertaken in way of the engine room.

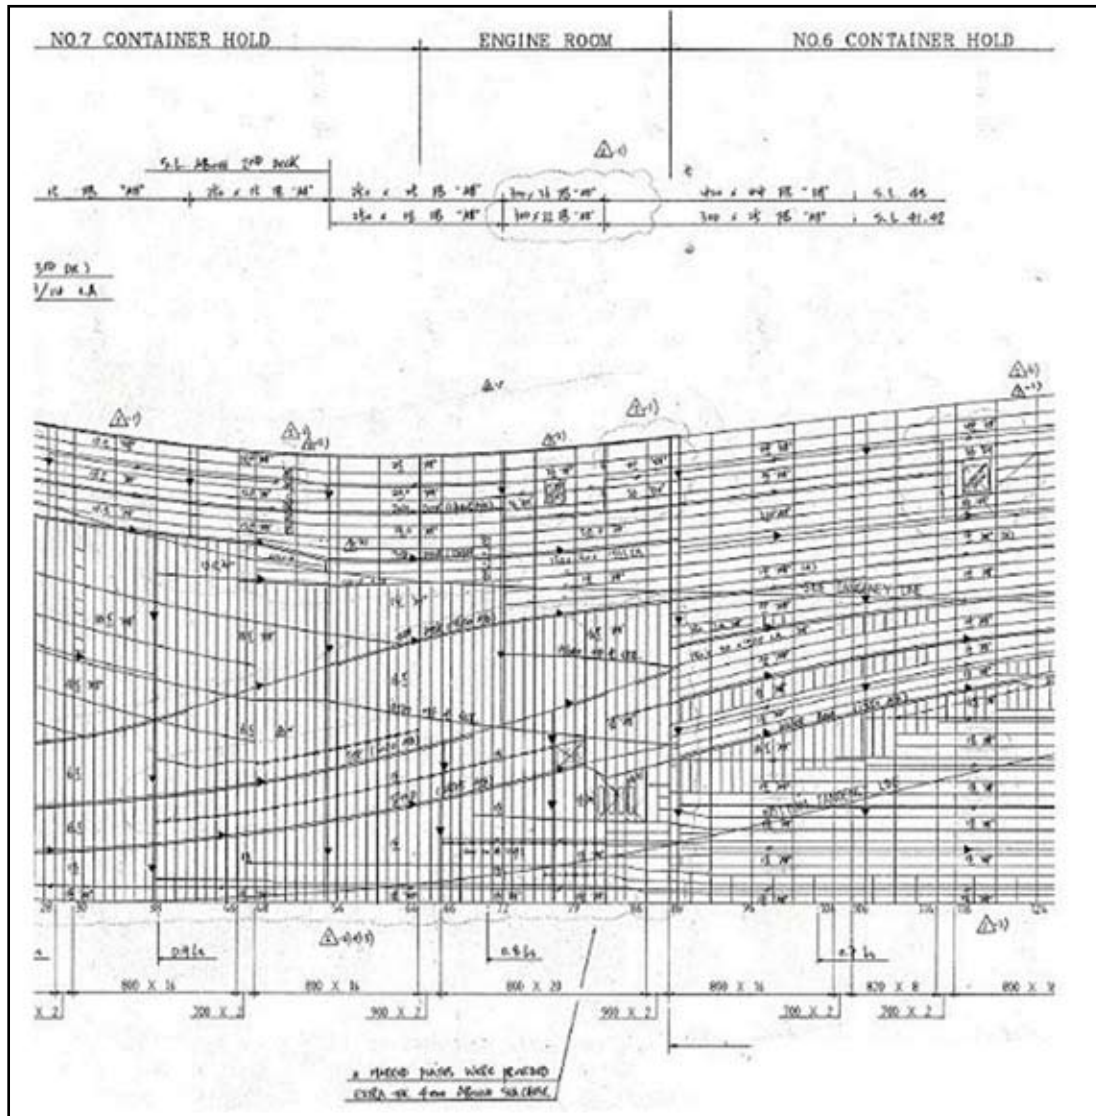
Figure 14

Aft of the engine room forward bulkhead (frame 88) the bottom structure and lower portion of the side shell up to the 4th deck (9620mm above base) changed to being transversely framed with plate floors spaced at 800mm (**Figure 14**). There was an area of framing transition in the bottom structure aft of frame 88 where longitudinals from the cargo hold region continued aft for a short distance before termination or replacement by intercostal stiffeners.

Extract of shell expansion drawing

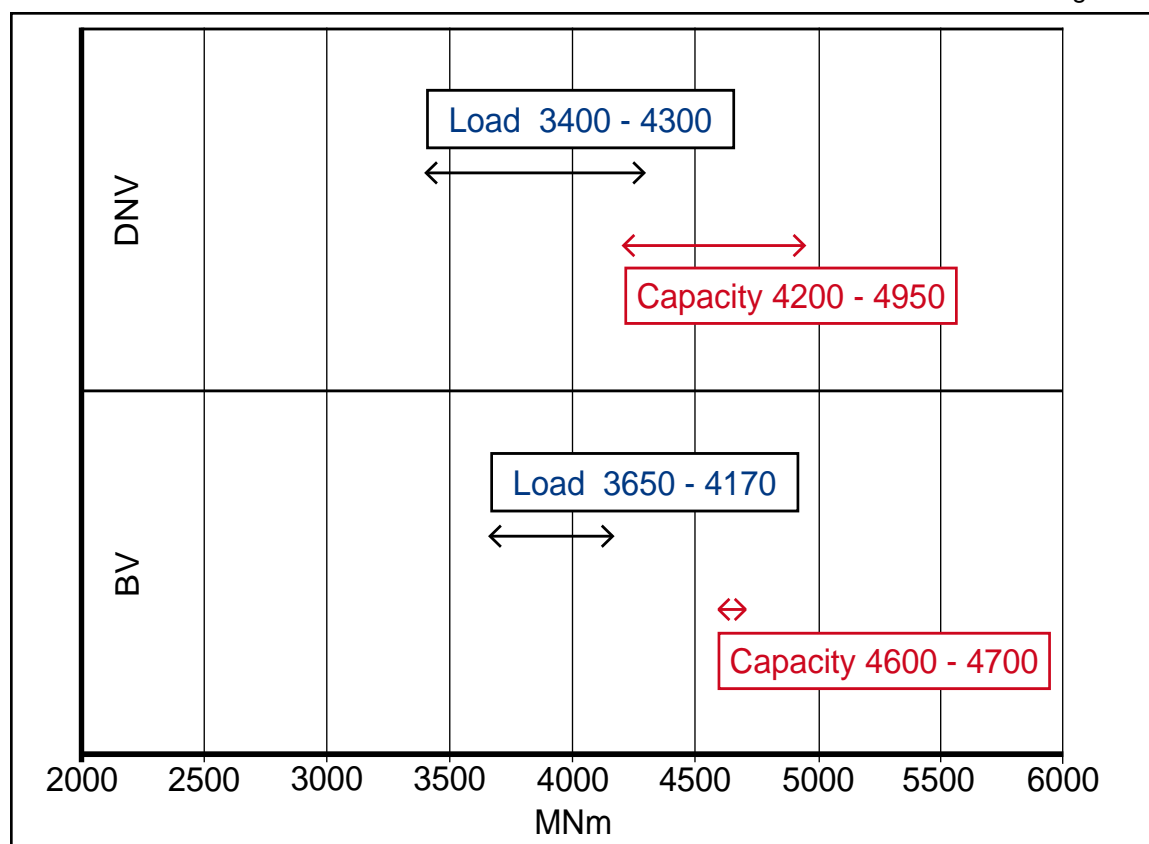
The DNV model indicates there was no margin between the maximum vertical bending moments experienced at the time of the failure and the design capacity of the hull structure. The BV analysis indicates the margin between the two values was about 430MNm. However, this margin was removed when whipping effect was taken into account.

Comparison of DNV and BV load and capacity assessments

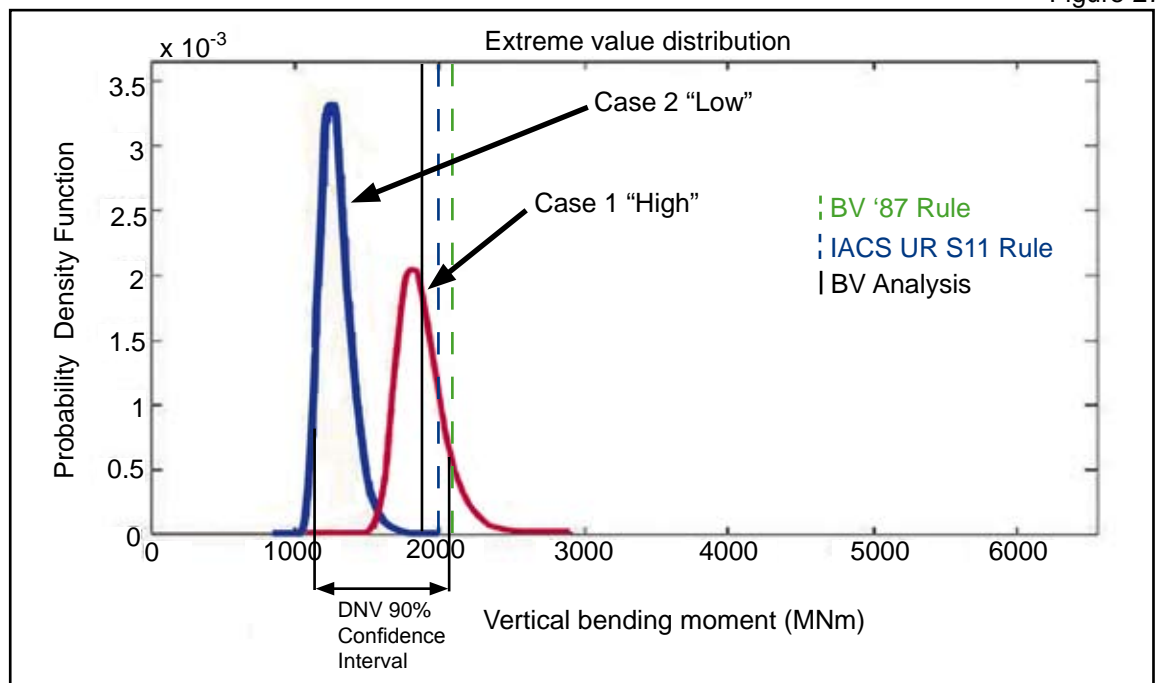
Figure 27

A comparison of the “high” and “low” wave loading cases used by DNV, the load range calculated by BV, the wave bending moments at frame 88 calculated in accordance with the BV rules applicable at the time of build (10^{-8} probability level), and the current IACS UR S11 requirement is shown at **Figure 27**. Although this comparison is simplistic and the results cannot be considered in isolation, it does indicate that the “high” DNV case and the upper end of the BV range were very close to the design bending moment required by the society's rule and the current IACS requirement. However, although the vertical wave bending moment acting on the hull at the time of the accident was potentially very high, it was unlikely to have appreciably exceeded either of the design values. Therefore, the waves encountered were within the bounds of normal wave theory; they were not freak waves.

Comparison of wave bending moments

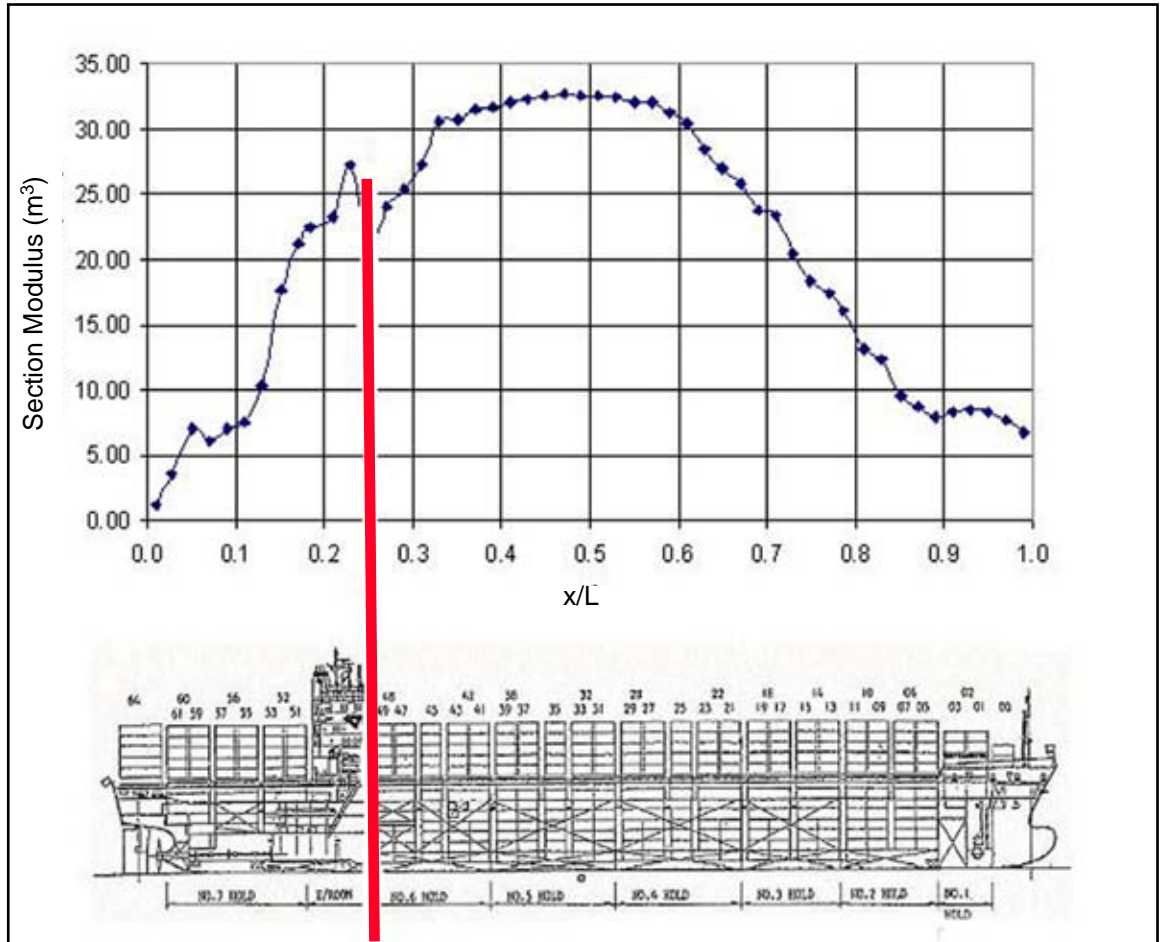
At the time *MSC Napoli* was built, her fine lines and resulting low block coefficient required her engine room to be further forward than most of the other ships being built at that time. However, because it was outside of the 0.4L amidships area, the applicable classification society rules did not require the buckling strength of the hull in this area to be checked. As a result, no calculations were made by either the ship builder or BV.

Keel section modulus

For a ship structure that maintains the same structural configuration over the majority of its length, the requirement to vary scantlings gradually from the amidships region to the end regions will give a gradual reduction in buckling strength outside the amidships region. This reduction in strength complements the usual reduction in global bending loads outside the amidships region. However, this assumption was not valid on *MSC Napoli* where there was a change in structural configuration from longitudinal framing amidships to transverse framing in the engine room where the hull stresses were almost as great as at her amidships region. The transverse framing in the engine room of *MSC Napoli* was an inherently weak structure under compressive loading.
