JRC - Learning Opportunity Notification (LON) - 003

Incident Details		Incident Impact	
Incident	Alexander L. Kielland	People	123 dead
Date of Incident	27-Mar-80	Environment	Minimal
Location/Country	Ekofisk Area, Norwegian Sector, North Sea	Asset (adjusted claim at the time of loss)	USD \$89.5 million
Type of Incident	Capsize	Reputation	
Offshore/Onshore	Offshore

Asset Type	Semi-Submersible		
Asset Status	Operational		
Immediate Cause	Damage to Structure		
Similar Root Cause Incidents	LON - 001, LON - 004		
Date Updated	05-Mar-21

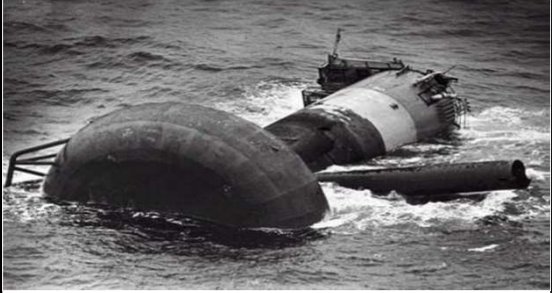
The Alexander L. Kielland was built as a semi-submersible drilling rig by Compagnie Francaise d'Entreprises Metalliques, Dunkerque, France. The rig was of a 'pentagon' design, with five legs (columns), and was one of eleven such designs, and in turn one of seven built by CFEM, albeit a modified version. The vessel was delivered to owners A.Gowart-Olsen A/S in 1976, and operated by Stavanger Drilling Company.

Investigation showed that the fracture in D-6 bracing was a fatigue failure. In this bracing there was a cut-out for a hydrophone, used for positioning control, with the column D being one of three columns with such an arrangement. The hydrophone support was fixed to the bracing by inside and outside fillet welds. Detailed post incident analysis showed the welding for the support was of poor quality and lacked penetration, this led to fractures in welded connection, which progressed to the circumference of the bracing itself, and included two-thirds of the circumference at the point of final failure. Fractures in the weld started in the construction yard as paint residue was detected on the fracture surfaces. The exact duration between initiation of cracks in the bracing and final failure was not accurately determined.
