JNRC - Learning Opportunity Notification (LON) - 009

Incident Details		Incident Impact	
Incident	Varanus Island	People	No direct people impact
Date of Incident	3 June 2008	Environment	Minimal
Location/Country	Varanus Island Gas Processing Plant, WA, Australia	Asset (OPSR advised loss at time of incident)	A\$ 60 million
Type of Incident	Fire & Explosion	Reputation	See Incident Description
Asset Type	Pipeline

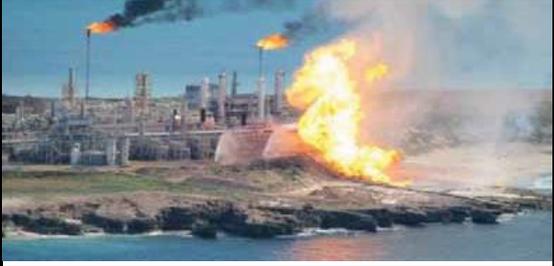
In the early afternoon (13h30) a high pressure 12" export gas sales line (SGL), operating since 1992, ruptured and the gas release ignited causing an explosion. The location of the incident was on the beach of Varanus Island in the region of the shore crossing. Almost immediately, an adjacent and parallel 12" high pressure gas inlet pipeline, which was only 226 mm apart from the SGL, also failed. Both pipelines directed intense jet fires towards the main gas processing plant, resulting in further ruptures of a 16" and 6" gas lines within the hour, and finally two 4" lines failed. Fire and debris from the explosion penetrated some 50 m into the gas plant. It was the failure of the two 4" lines that caused most of the plant damage.

The initial explosions created an 8m x 30m crater on the beach to a depth of 2m, exposing pipelines and showered the NNE section of the plant with limestone rocks, stones and concrete coating from the ruptured pipelines.
